REPORT ON THE CRASH OF THE TU-154M AIRPLANE ON APRIL 10, 2010

OVER THE SMOLENSK-SEVERNEY AIRDROME IN THE RUSSIAN FEDERATION

### **FINAL CONCLUSIONS OF THE REPORT DATED APRIL 11, 2022**

EXCERPT FROM APRIL 11, 2022 REPORT ON 2010 CRASH OF THE POLISH AIR FORCE ONE  
OVER SMOLENSK AERODROME IN RUSSIA

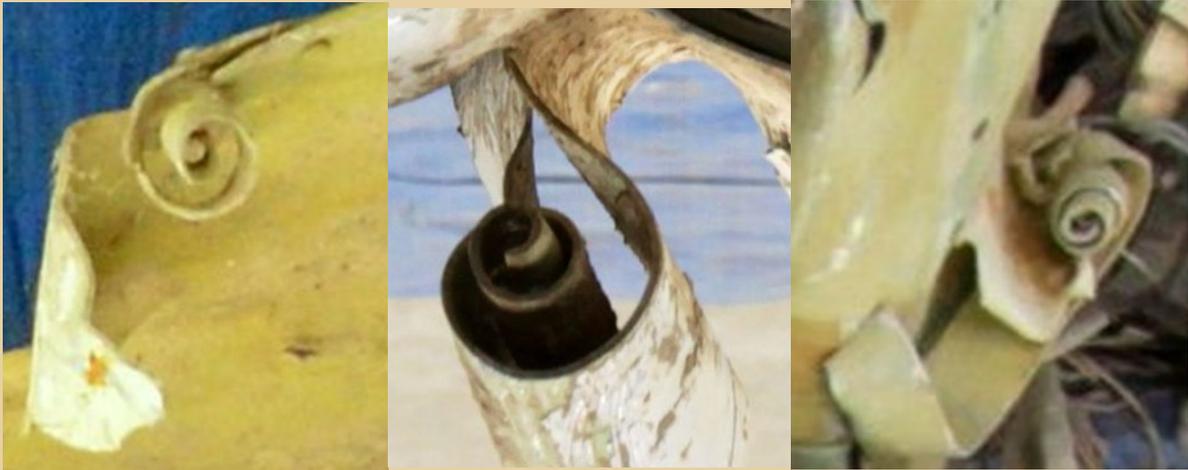
- b) reconstruction of the damage to the left wing and other parts of the plane scattered on the site, and identification of the location of the explosion and numerous post-explosion curls of the left wing tip, fuselage, and cockpit covering, which constitute indisputable evidence of the explosion;

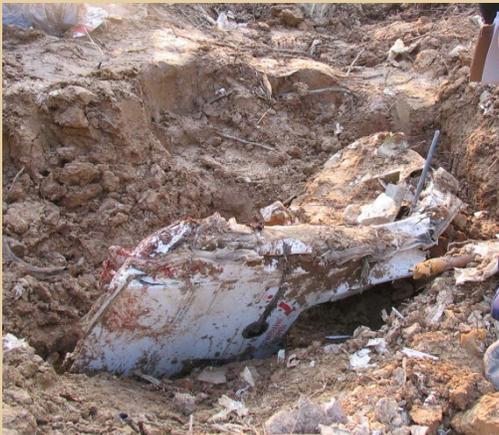
Another NIAR study was dedicated to the analysis of driving the passenger door into the ground in such a way that the door is buried the same way as in reality, and the resulting deformation and damage is similar to that observed in reality. The results concluded that the necessary condition to reach this goal is a minimum vertical speed before impact with the ground of about 125m/s while the horizontal speed needs to be smaller than 30m/s.

The only way to obtain the necessary conditions for the door to be injected perpendicularly into the ground is for the door to be violently ejected by high internal pressure within the fuselage while the fuselage is still in the air. The position of the fuselage must be oriented with the left wing pointing into the ground and the cockpit pointing slightly down. In this configuration, the door launch speed vector was directed to the ground and backward, which resulted in an increase of the vertical speed from 18m/s to over 125m/s and a decrease of the horizontal speed from 76m/s to below 30m/s.
