# POLISH AIR FORCE ONE

### **FINAL REPORT ON THE CRASH OF THE TU-154M AIRPLANE ON APRIL 10, 2010**

## **CONCLUSIONS OF THE FINAL REPORT DATED APRIL 11, 2022**

EXCERPT FROM APRIL 11, 2022 REPORT ON THE 2010 CRASH OF THE POLISH AIR FORCE ONE  
OVER SMOLENSK AERODROME IN RUSSIA

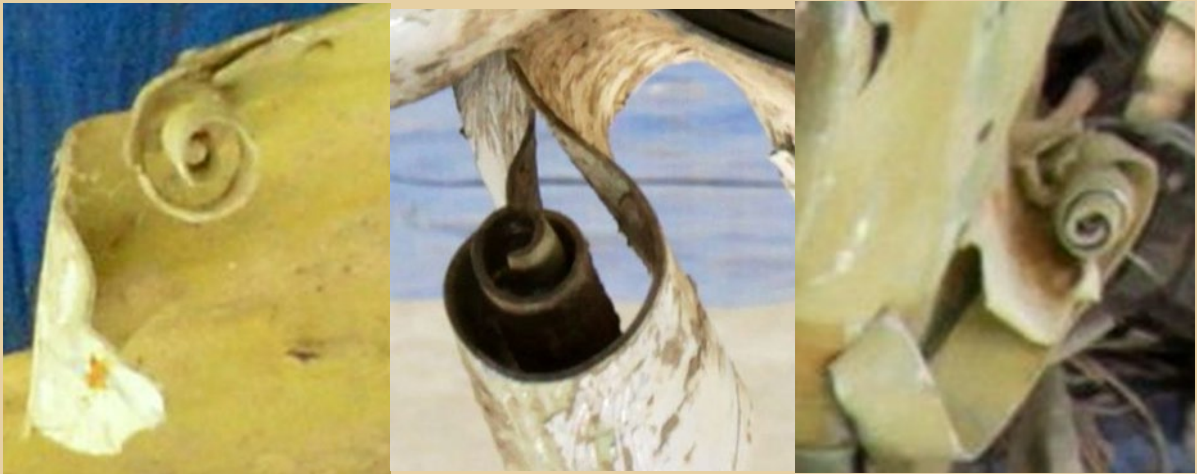
- b) reconstruction of the damage to the left wing and other parts of the plane scattered on the site, and identification of the location of the explosion and numerous post-explosion curls of the left wing tip, fuselage, and cockpit covering, which constitute indisputable evidence of the explosion;

- c) crash examination of the passenger door no. 823 driven 1 m deep into the ground as a result of the explosion, along with fragments of the body of one of the victims;

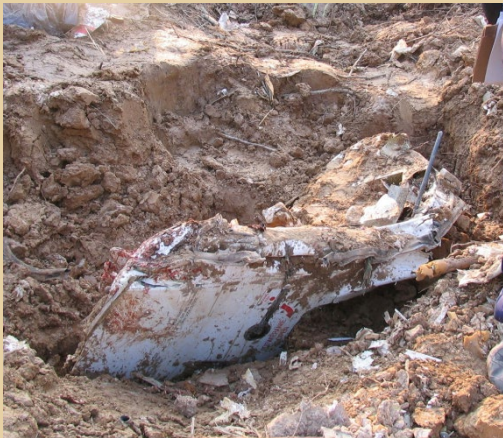
Another NIAR study was dedicated to the analysis of driving the passenger door into the ground in such a way that the door is buried the same way as in reality, and the resulting deformation and damage is similar to that observed in reality. The results concluded that the necessary condition to reach this goal is a minimum vertical speed before impact with the ground of about 125m/s while the horizontal speed needs to be smaller than 30m/s.

The only way to obtain the necessary conditions for the door to be injected perpendicularly into the ground is for the door to be violently ejected by high internal pressure within the fuselage while the fuselage is still in the air. The position of the fuselage must be oriented with the left wing pointing into the ground and the cockpit pointing slightly down. In this configuration, the door launch speed vector was directed to the ground and backward, which resulted in an increase of the vertical speed from 18m/s to over 125m/s and a decrease of the horizontal speed from 76m/s to below 30m/s.
